IMPORTANCE OF CRACK INVESTIGATIONS- MARINA APRON SLABS

By: David Tuck, Sr. Project Manager- Seawall Professionals of FL

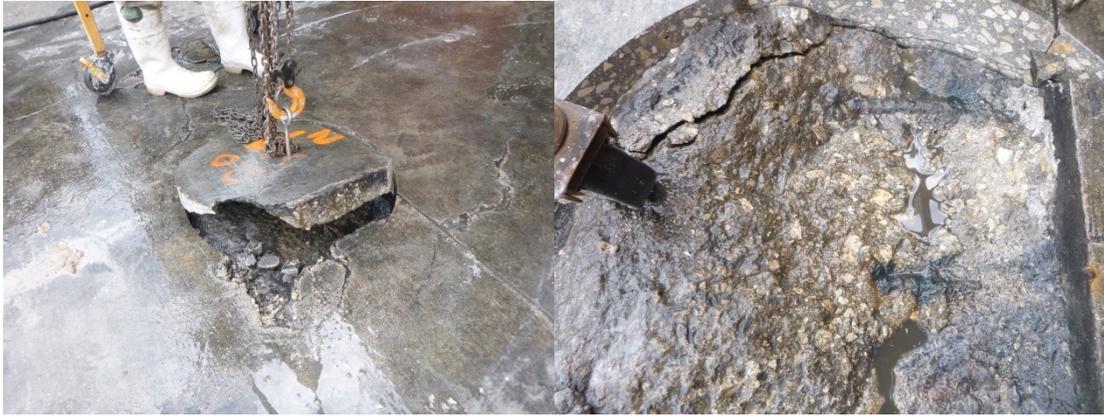
While coring an apron slab for the installation of point-loaded pin pilings, we always run into this situation. Even though this boring was made to full depth (20”), pulling it reveals total separation at the level of the first mat of steel reinforcing. You can see in picture 2 that the steel has corroded and expanded to form this separation.

The compaction values had fallen to the point that there were voids up to 2” evident throughout the approximate 9000 sq. ft. of apron at this particular Marina. During coring, all cores fell when the drill made it all the way through.
